DEPARTMENT OF TRANSPORTATION**DIVISION OF ENGINEERING SERVICES**

Hinge-K Pipe Beam Assembly 102A-1: 9/22/09

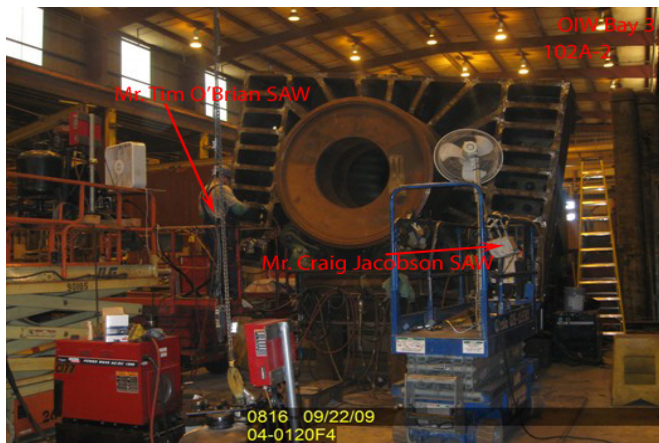
Note: QA Inspector spoke with QC Inspector Jose Salazar and Mr. Salazar explained that the following weld joints, on the radial stiffeners, were completed by Mr. O'Brian and Mr. Jacobson, by end of shift: WJ #W1-22, W1-78 and W1-69. Mr. Salazar also explained that 100% magnetic particle testing was performed on the above mentioned FCAW root passes and no rejectable indications were found, per AWS D1.5 and contract requirements. See attached picture below.

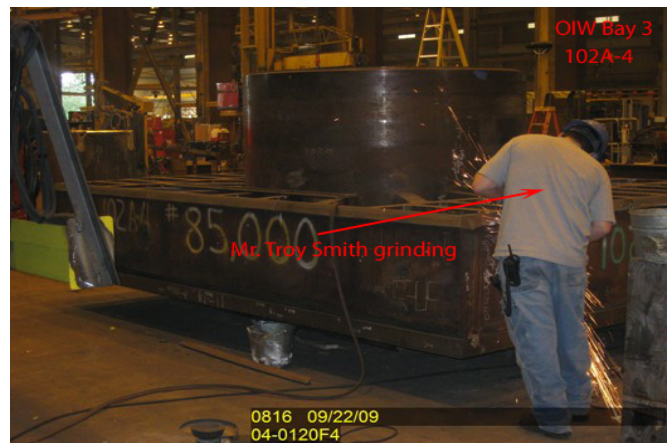
Hinge-K Pipe Beam Assembly 102A-4: 9/22/09

a111-4 Forging to a110-4 Base Plate

QA Inspector noticed that Mr. Troy Smith was in-process of flame cutting and grinding (utilizing a mechanical grinder), the bevel prep, on the b106/ab106 stiffener plates, in preparation for fitting the a109 Post Tension Cap plate. QA Inspector reviewed the applicable OIW approved drawings and noted that this was a partial joint penetration (PJP AWS D1.5 TC-P4-S), 60 degree bevel prep angle and zero root opening. QA Inspector randomly measured the completed bevel prep angle on the b106 stiffener plate, utilizing a bridge cam gauge and noted the angle to be 60 degrees, which appears to be in compliance with AWS D1.5 and contract requirements. See attached pictures below.
